RICHWOODS MINE 'B' MILL DAM

MO. 31404

**PHASE 1 INSPECTION REPORT
NATIONAL DAM SAFETY INSPECTION**

SEPTEMBER 1980

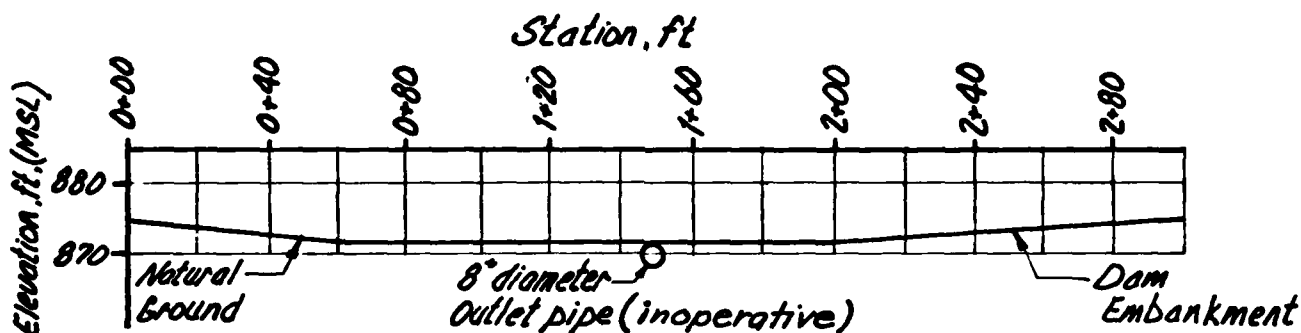
Fig. 3B

- a. General. Dam was inspected on 3 June 1980 without the owner's representative present. This inspection indicated the dam is in an unsatisfactory condition.
- b. Dam. The Richwoods Mine B Mill Dam consists of coarse tailings locally referred to as "chat". This material is sandy gravel and sand (GW, SW). It is cohesionless and can be easily eroded. The material is end-dumped on the crest of the dam by trucks. Compaction is limited to truck traffic. Slopes on the dam generally are at the angle of repose for this material, 33 to 35 degrees. A 40 degree slope angle was measured on portions of the maximum section (Fig. 3B).

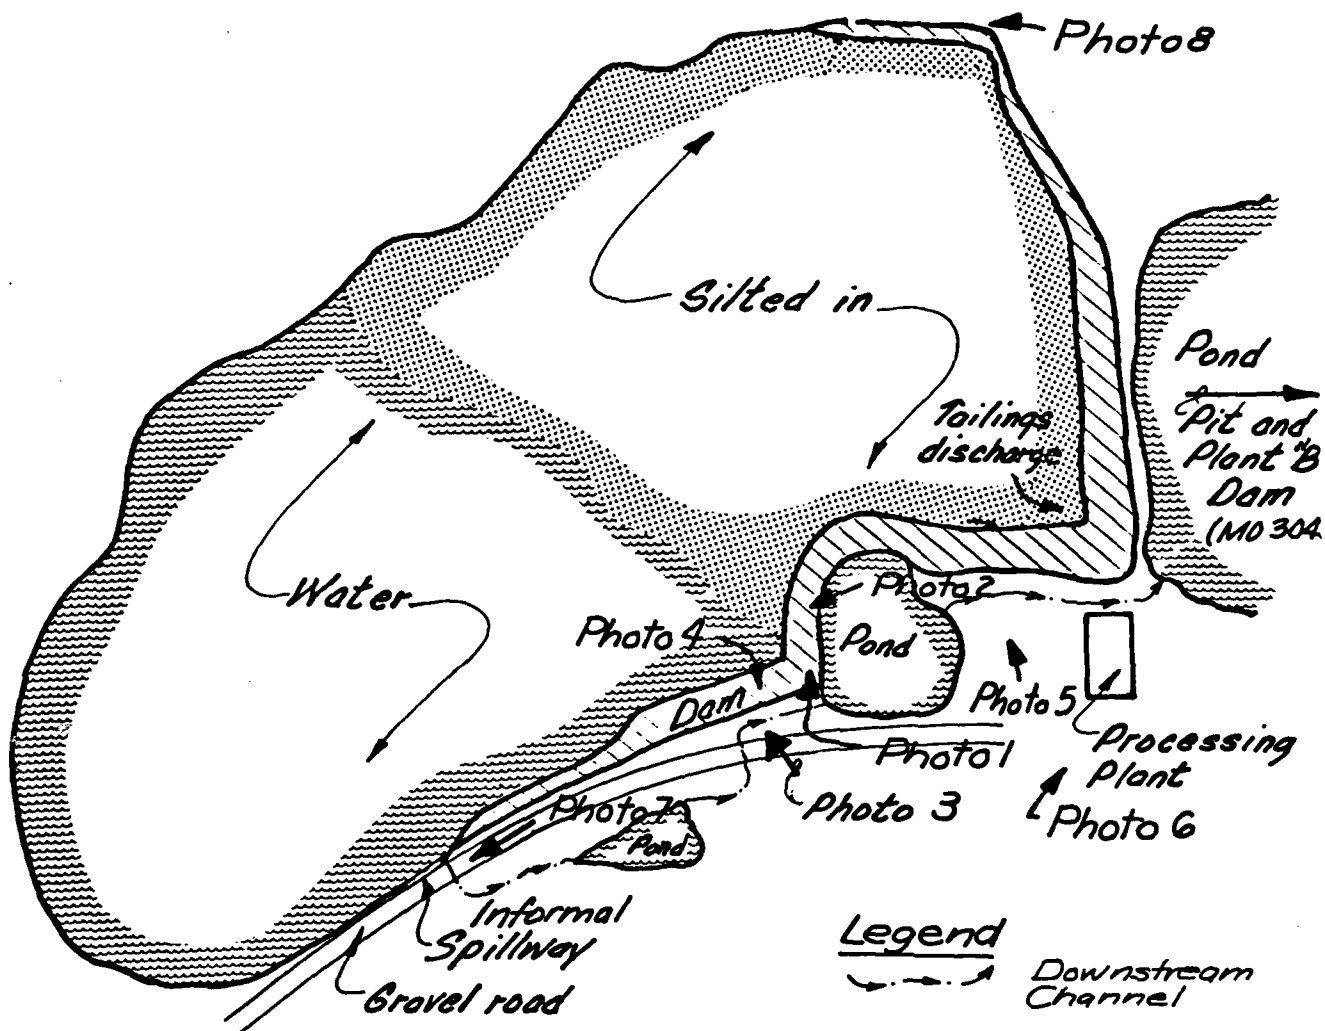
PHOTO LOCATION SKETCH

The discharge channel passes along the toe of a portion of the dam (Fig. A1, Appendix A; Photos 3 and 4). In this area, it appears the channel has eroded the toe of the slope. Evidence of small (less than 5 yd³) slope failures was noted in this area (Photo 3).
